Forestry Best Management Practices Monitoring

2018 FORESTRY Best Management Practices FIELD REVIEW RESULTS

Department of Natural Resources & Conservation
Forestry Division • Missoula, MT 59804-3199

2018 FORESTRY BMP FIELD REVIEW REPORT

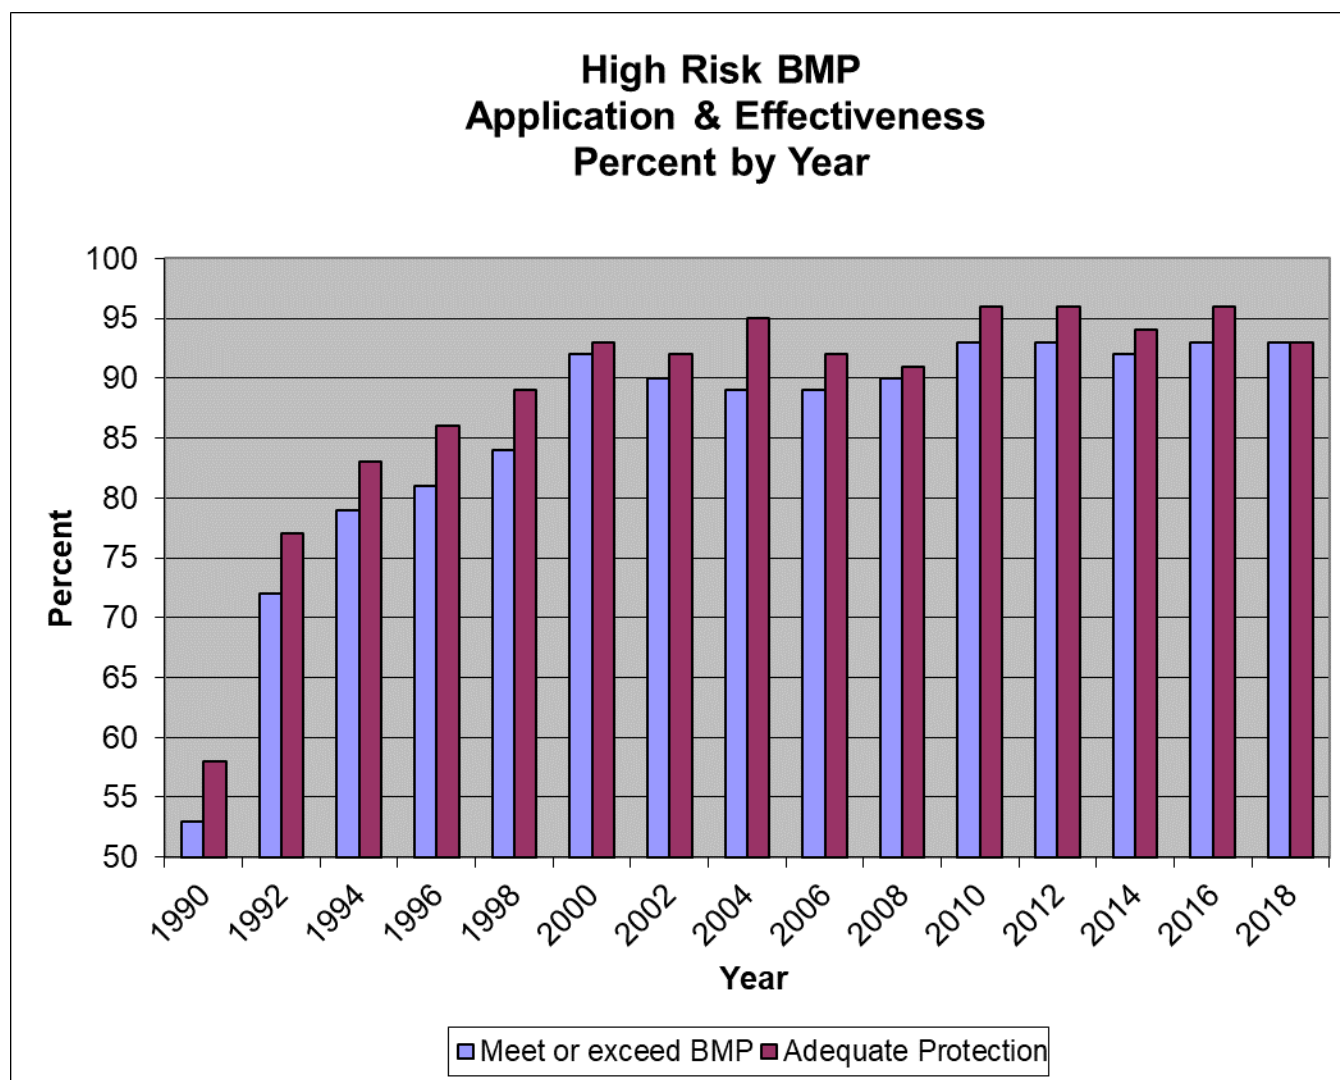
Application (Table 3 vs Table 10)				
BMPs	Meet or Exceed	Minor Departure	Major Departure	Gross Neglect
All	97%	3%	<1%	0%
High Risk	92%	7%	1%	0%
Effectiveness (table 6 vs table 11)				
BMPs	Meet or Exceed	Minor impacts	Major/ Temp Impacts	Major Impacts
All	98%	1+%	<1%	0%
High Risk	93%	<5%	2%	<1%

Figure 1 below gives a graphical representation of this discussion.

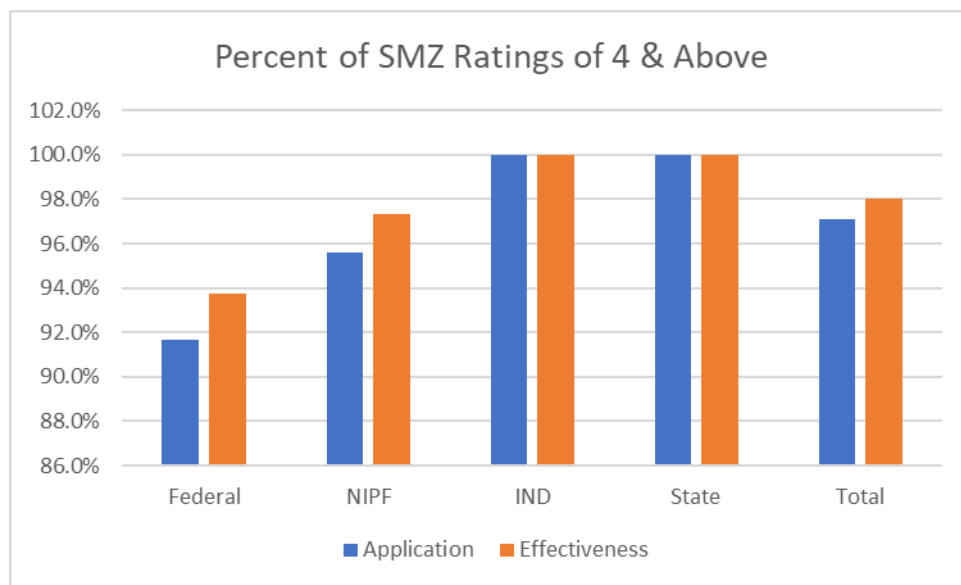
Figure 2:

SMZ effectiveness was also very high; 98% for all ownerships combined. Of the 308 SMZ evaluations, 302 provided adequate protection (a 4 or 5 rating); the 6 impacts were rated Minor/Temporary (3 rating) and, again, there were no impacts rated as Major/Temporary or Minor/Prolonged (2 rating), nor were there any ratings of Major and Prolonged impacts (1 rating).

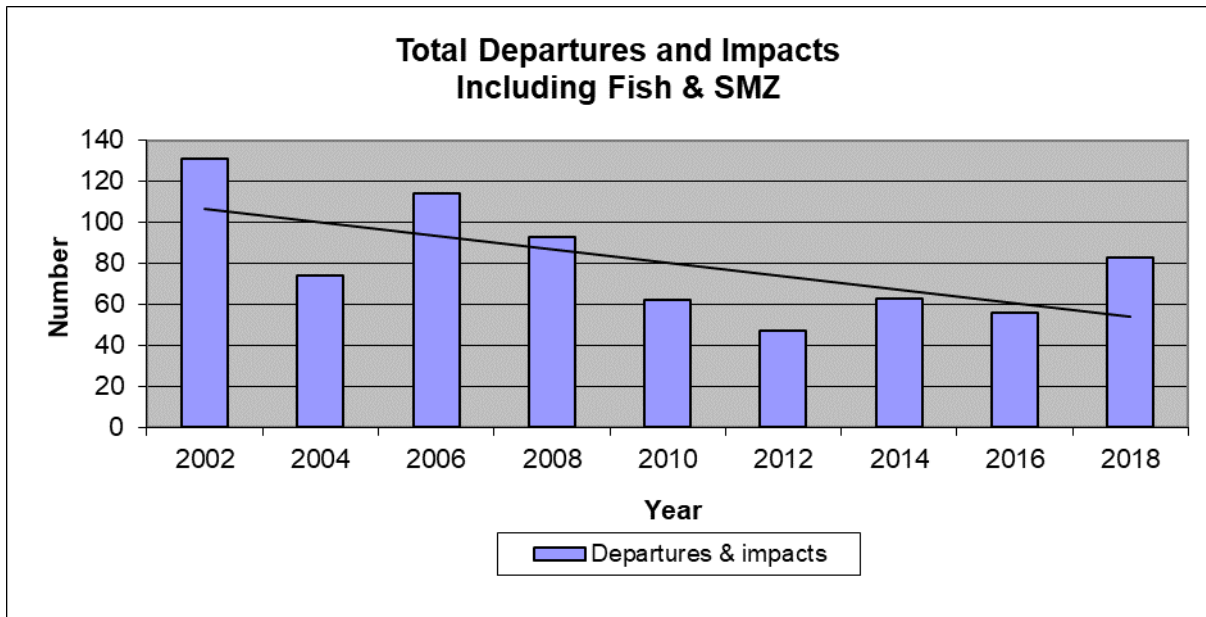
Figure 3:

Figure 2, graphically illustrates that although the total departures and impacts have varied somewhat, the overall trend is positive; an overall reduction in the total number.

Combining application and effectiveness, the 2018 field reviews rated a total of 2,772 (1386 x 2) BMP practices for the 42 sites. There was a combined total of 68 ratings with a departure or impact. **Which translates to a departure or an impact occurring on 2.5% (68/2772) of all practices rated.**

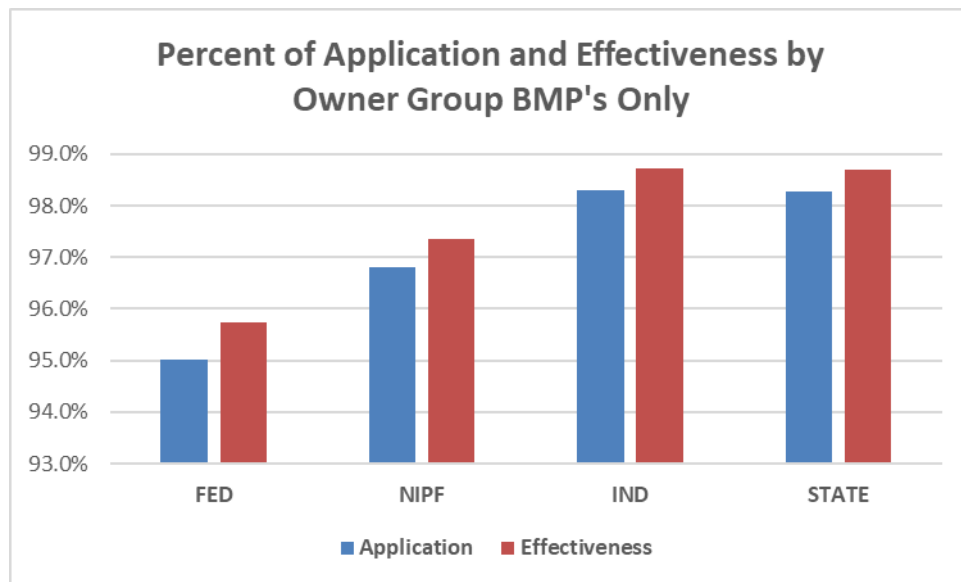
Figure 7:

The 2018 field review results across all ownership groups for application were 97.2% for all BMP and SMZ categories combined. Across all ownerships 3388 ratings were made for both application and effectiveness (1386 BMP's plus 308 SMZ times two for app & eff). There was a total of 83 departures and impacts (68 BMP and 15 SMZ). This translates to an overall compliance rating of just under 98%.
